Forest Pest Management Report

R-3 82-1

BIOLOGICAL EVALUATION
Hazard Trees and Dwarf Mistletoe
in Six Summer Home Areas

Payson Ranger District,
Tonto National Forest, Arizona

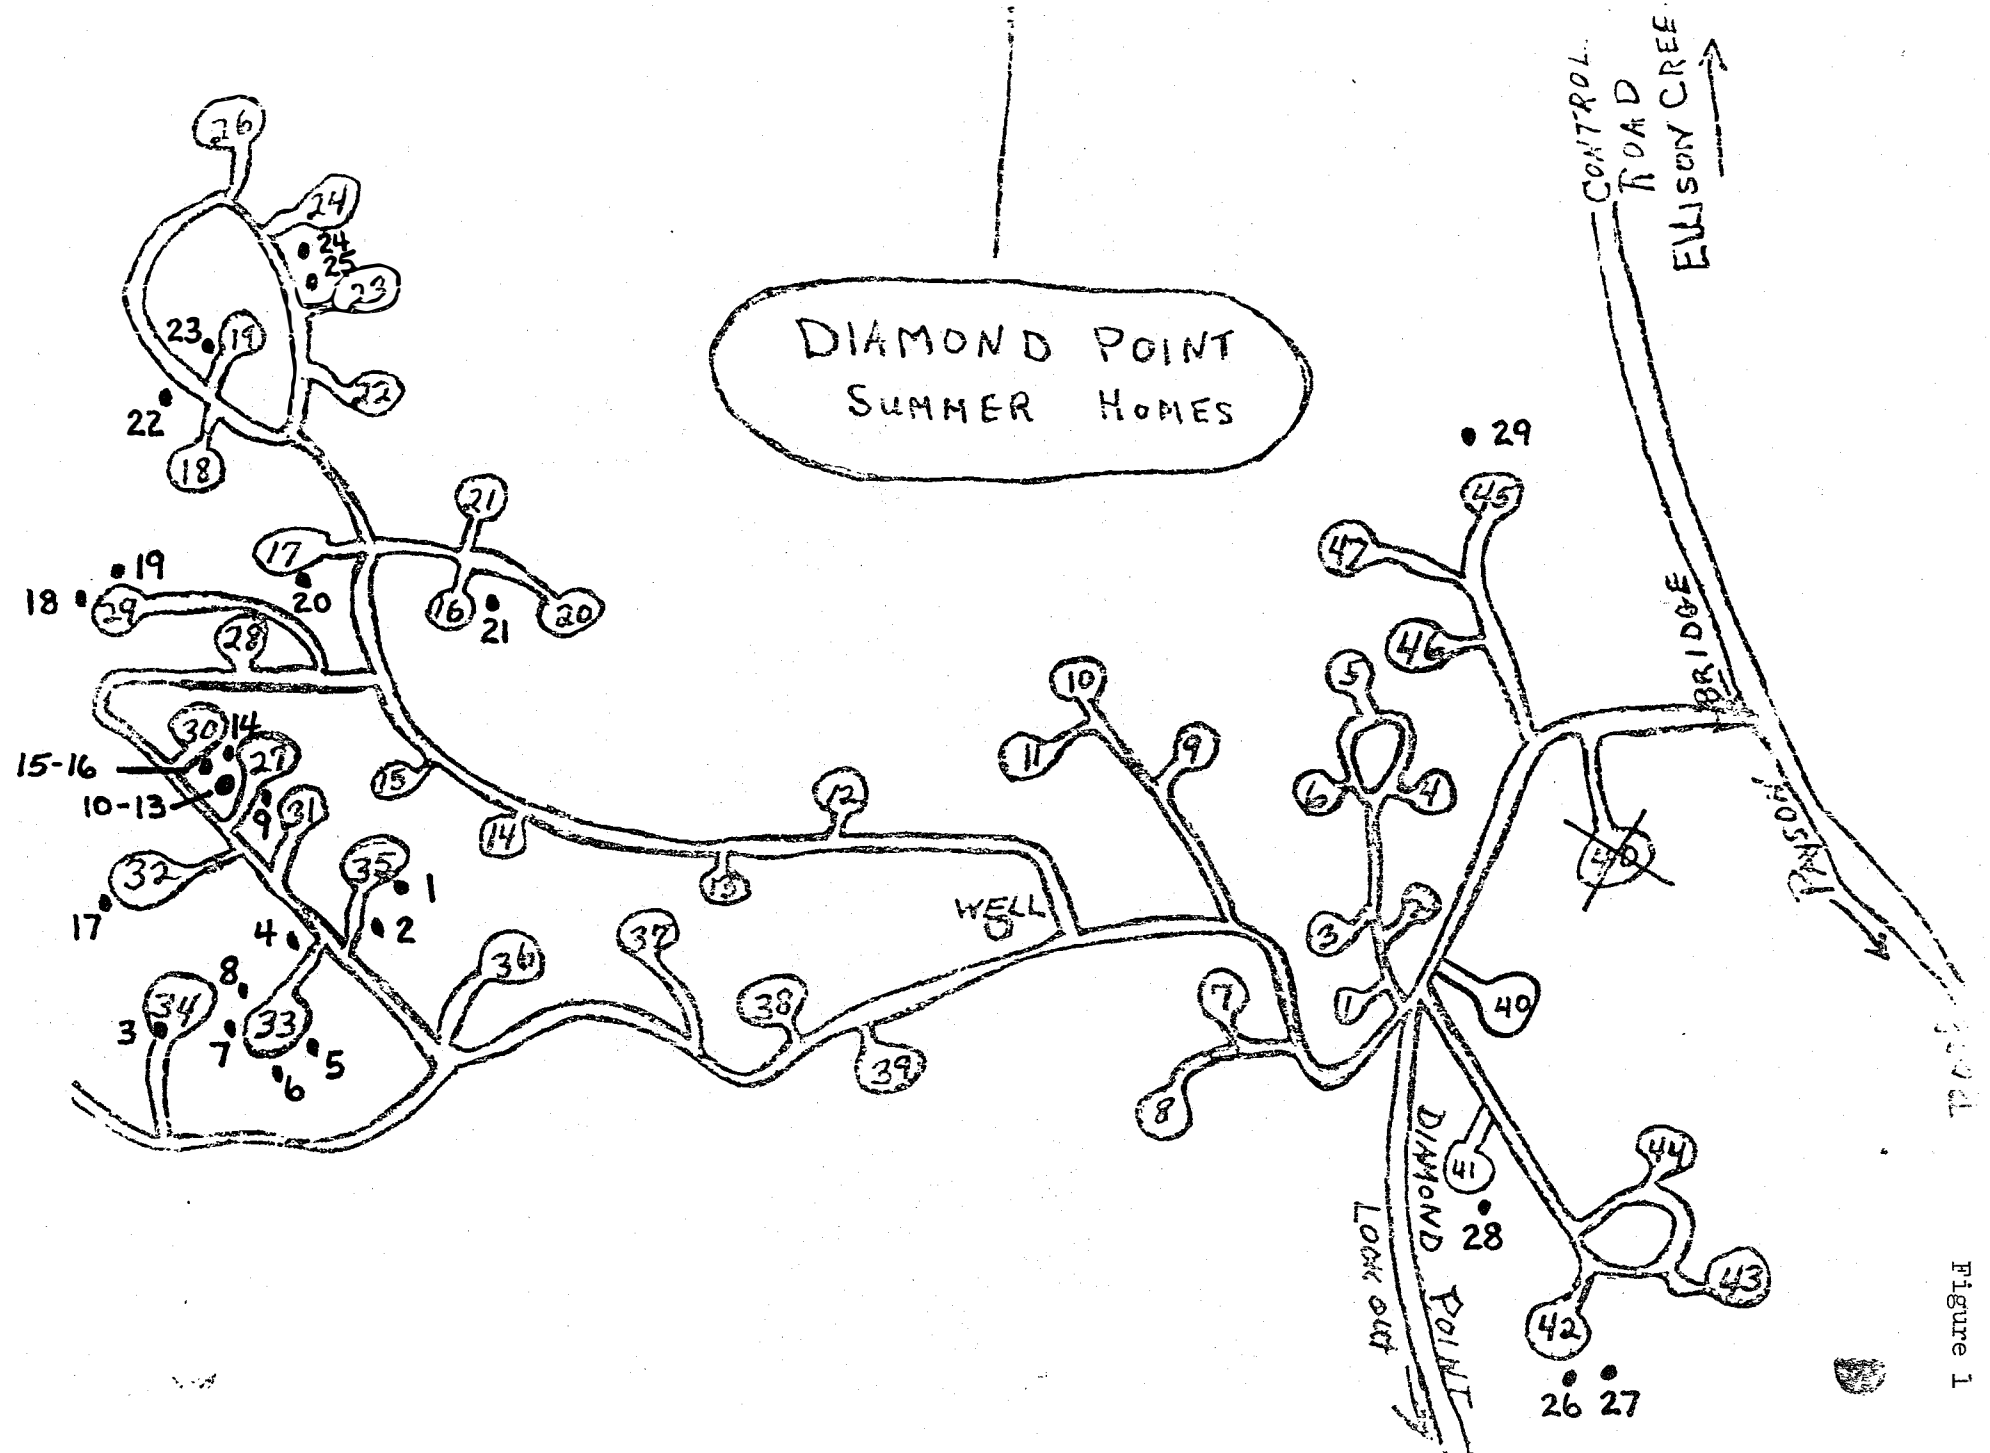
Figure 1

- Diamond Point - 29 trees rated, figure 1, appendix 1.
- Ellison Creek - 45 trees rated, figure 2, appendix 2.
- See Canyon - 70 trees rated, figure 3, appendix 3.
- Thompson Draw, Block 1 - 33 trees rated, figure 4, appendix 4.
- Thompson Draw, Block 2 - 43 trees rated, figure 5, appendix 5.
- Washington Park - 17 trees rated, figure 6, appendix 6.

Diamond Point--No dwarf mistletoe found.

Tree No.	Lot No.	Location	Species	DBH	Potential Target			Rating	Dead	Comments
					Structure	Vehicle	People			
1	35	40' E. cabin	PP	15		X		L/L	X	Limb defect
2	35	100' S. cabin	PP	19			X	L/M		Root & butt rot, by driveway
3	34	50' S. cabin	PP	9	X	X		M/H		Heart & butt rot
4	33	W. corner of road and driveway	PP	9		X		L/M	X	Root rot
5	33	30' SE cabin	PP	8			X	M/M	X	
6	33	50' S. cabin	PP	13			X	M/M	X	
7	33	60' SE cabin	PP	6			X	M/M	X	
8	33	60' SE cabin	PP	8			X	M/M	X	
9	27	60' SE cabin	PP	5			X	M/L	X	
10	27	60' SE cabin	PP	5			X	M/L	X	
11	27	60' SE cabin	PP	6			X	M/L	X	
12	27	60' SE cabin	PP	9			X	M/L	X	
13	27	60' SE cabin	PP	4			X	M/L	X	
14	27	10' S. cabin	PP	11	X		X	L/M		Dead top
15	27	30' W. cabin	PP	4			X	M/L	X	
16	27	30' W. cabin	PP	4			X	M/L	X

Tree No.	Lot No.	Location	Species	DBH	Potential Target			Rating	Dead	Comments
					Structure	Vehicle	People			
17	32	20' W. cabin	PP	15	X		X	L/H	X	New dead
18	29	30' W. cabin	PP	9			X	M/M	X	
19	29	15' NE cabin	PP	10			X	M/H	X	New dead
20	17	30' SW cabin	PP	27	X			M/M	X	Limb defect
21	16	80' N. cabin	PP	7	X			L/M	X	New dead, powerline
22	19	Across road from Lot 19	PP	25	X			L/L	X	Limb defect, powerline
23	19	30' SW cabin	PP	8			X	L/M	X	New dead
24	24	40' S. cabin	PP	4			X	M/M	X	10° lean
25	24	40' S. cabin	PP	4			X	M/M	X	10° lean
26	42	45' S. cabin	PP	7			X	M/L	X	
27	42	15' S. cabin	PP	5			X	M/L	X	
28	41	30' S. cabin	PP	17	X		X	M/H	X	
29	45	120' N. cabin	PP	25			X	L/L	X	In stream

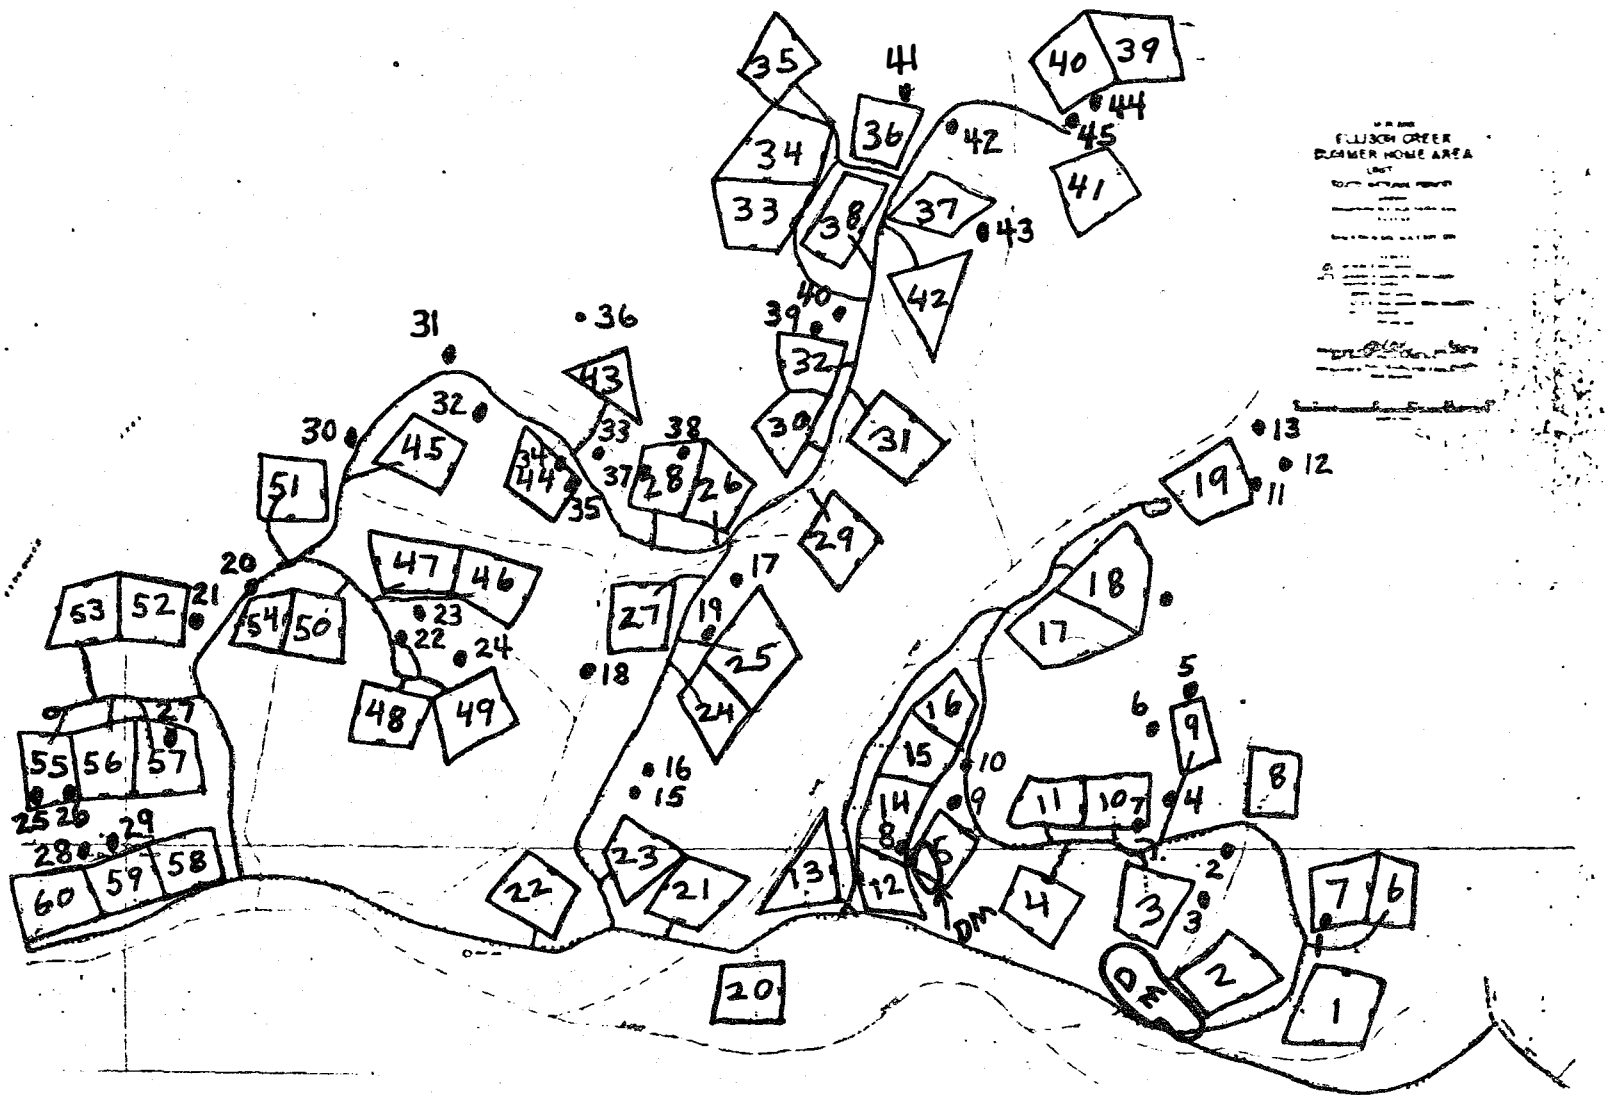
Figure 2

Ellison Creek--Two areas of dwarf mistletoe were found; trees were marked for cutting and pruning to completely sanitize the area (figure 2, appendix 2).

Tree No.	Lot No.	Location	Species	DBH	Potential Target			Rating	Dead	Comments
					Structure	Vehicle	People			
1	7	100' S. cabin	PP	24	X	X		L/M		Dead top, lightning scar
2	8-3	between 8 & 3	PP	32	X			H/H	X	Guy wire attached, supports powerline
3	3		PP	24	X			M/H		Lean, basal cavity, root and butt rot, weak crotch, dead top, powerline
4	9	by driveway	PP	27		X		H/M	X	
5	9	rear of house	PP	26	X		X	M/H		Root and butt rot, dead limbs, carpenter ants, wood borers
6	9-10	between 9 & 10	PP	30	X		X	H/M		Basal cavity, root and butt rot, dead limbs
7	10	by driveway, picnic area	PP	26		X	X	H/M	X	Lean, butt rot
8	5	1' from house	AJ	23	X			L/L		Lean, root heaving, dead limbs, mechanical injury
9	5		PP	26			X	L/H		Lean, dead limbs, guy wire to powerline attached

Tree No.	Lot No.	Location	Species	DBH	Potential Target			Rating	Dead	Comments
					Structure	Vehicle	People			
10	5	Main road near 5	Oak	19			X	H/M	X	Lean, butt rot, dead limbs
11	19	30' E. house	PP	27	X		X	M/H	X	Dead limbs
12	19		PP	23	X		X	H/M	X	Lean, dead limbs
13	19		PP	18	X		X	M/M		Lean, butt rot
14	18	90' E. house	PP	34	X		X	H/M	X	Dead limbs, tree 70' high
15	18		PP	21		X		H/M	X	Lean 10° toward road, butt rot
16	18		PP	25		X		L/L	X	Lean 15° away from road
17	18		PP	24	X			M/M	X	Dead limbs, telephone line attached
18	27	10' from house	PP	11	X			M/H	X	New dead
19	25	by driveway	PP	30	X	X		M/M		Lean, basal cavity, root and butt rot, heart rot
20	54		PP	24	X			H/M	X	Dead top, 10° lean, powerline
21	52		PP	21		X		M/L	X	Lean 15°, dead snag

Tree No.	Lot No.	Location	Species	DBH	Potential Target		Rating	Dead	Comments
					Structure	Vehicle People			
22	48	near road	PP	14		X	L/L	X	Powerline
23	47	near road	PP	17		X	L/L	X	Powerline
24	49		PP	23		X	L/L	X	Powerline
25	55		PP	19	X		L/M		Basal cavity, new dead, 15° lean
26	55		PP	26		X	M/L	X	Old dead
27	57		PP	21	X	X	L/H		New dead, 15° lean towards house
28	59	30' N. cabin	PP	5		X	L/M	X	
29	59	30' N. cabin	PP	8		X	L/M	X	
30	59	NW of cabin	PP	30	X	X	L/M		Lean 5°, dead limbs, roots undercut by road bank, thin crown
31	59	by road	PP	24		X	H/L	X	
32	59	by road	PP	19		X	H/L	X	
33	59	by road	PP	29		X	L/M	X	
34	44	by road; in drive-way	PP	8	X		M/H	X	Lean
35	44	30' N. cabin	PP	16	X		M/M	X	Root heaving, lean toward powerline

Tree No.	Lot No.	Location	Species	DBH	Potential Target			Rating	Dead	Comments
					Structure	Vehicle	People			
36	43		PP	28		X	X	L/M	X	New dead, dead limbs
37	28	30' N. house	PP	35	X			L/H		Lean 10°, dead limbs
38	28	between 26 & 28	PP	30	X		X	M/H		Dead top, basal cavity, butt rot, heart rot
39	32		PP	24			X	L/L		Lean 20°, root heaving
40	32		PP	32			X	M/L	X	Butt rot, dead limbs
41	36		PP	20	X			M/H	X	Lean 15°
42	36	by road	PP	20		X		L/M	X	
43	37	southside 30' from house	PP	25	X			H/L	X	Lean 10°
44	40	on road	PP	21	X			M/L	X	Lean 15°, root rot
45	40		PP	31	X			L/M		Dead top, butt and root rot, lightning struck, powerline attached, lean 5°

<u>d.b.h.</u>	<u>DM Rating</u>	<u>Action</u>
24	2	P (prune infected branches)
19	2	P
18	2	P
18	1	P
12	2	P
12	3	P
11	2	P
11	1	P
8	1	P
8	3	P
7	1	P
6	1	P
6	1	P
4	2	P
31	4	C (cut tree)
26	5	C
15	4	C
13	1	C
12	3	C
10	5	C
10	5	C
9	2	C
8	3	C
7	3	C
6	3	C
6	2	C
4	6	C
4	2	C
4	2	C
3	2	C
3	3	C
2	2	C
2	6	C
2	6	C
2	6	C
.5	2	C

<u>d.b.h.</u>	<u>DM Rating</u>	<u>Action</u>
8	2	C
8	2	C
5	1	C

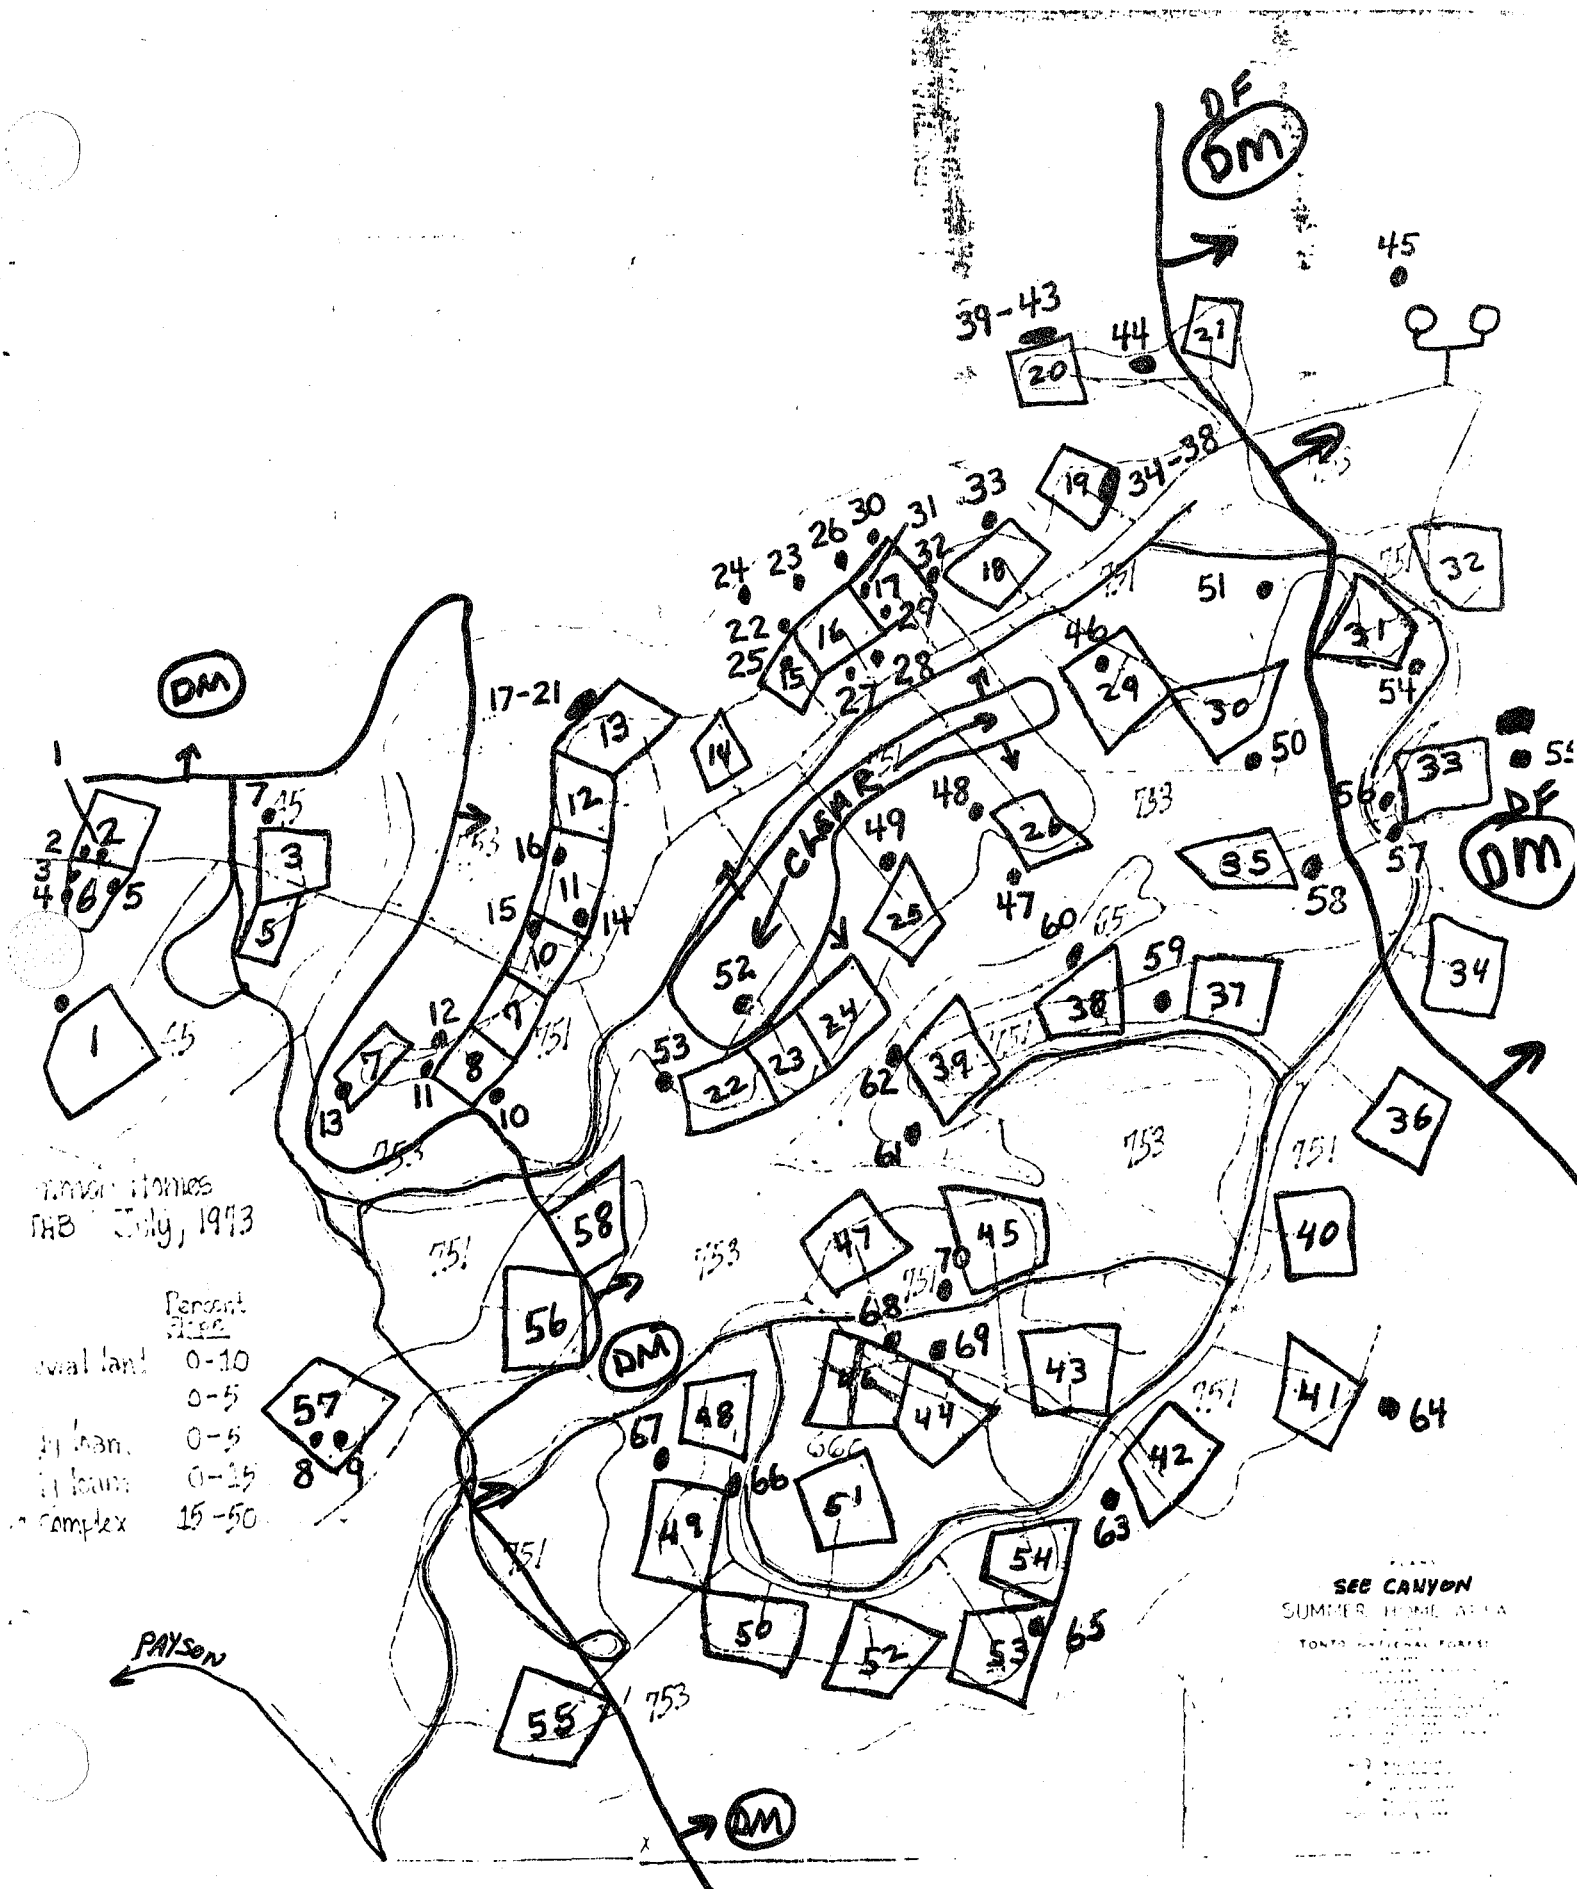
Figure 3

See Canyon--This area is heavily infected with ponderosa pine dwarf mistletoe. There is an uninfected section (marked "clear" in figure 3) in the center, and the west side is also uninfected. Douglas-fir dwarf mistletoe was found east of a line from lots 21, 31, 33, and 34. The prescription for See Canyon is to thin in overstocked areas removing infested trees and to broom prune large, valuable trees. Forty-six trees were marked for broom pruning (orange paint) (figure 3, appendix 3).

Tree No.	Lot No.	Location	Species	DBH	Potential Target			Rating	Dead	Comments
					Structure	Vehicle	People			
1	2	60' S. cabin	PP	8	X			M/M	X	Near outhouse
2	2	60' S. cabin	PP	7	X			M/M	X	Near outhouse
3	6		PP	6	X			L/M	X	Recent dead, near outhouse
4	6	N. of cabin	PP	5	X			L/M	X	
5	6	N. of cabin	PP	7	X			L/M	X	Recent dead
6	1		PP	12	X			M/H	X	
7	3	15' N. of cabin	PP	3	X			M/H	X	Recent dead
8	57	west of canyon	PP	8	X			L/L	X	Recent dead
9	57		PP	11	X			L/M	X	Recent dead
10	8	SE of cabin	PP	22	X			H/H		Lean, rotten branches
11	8	SW from cabin 60'	PP	25			X	H/M	X	Old dead, 10° lean
12	8	SW from cabin 60'	PP	24	X			H/M	X	Old dead, 10° lean
13	7	S. cabin 25' drive-way	PP	33	X			L/M		Compacted soil, thin crown, dead branches, 3 basal wounds
14	10	NE 30' from cabin	Oak	32			X	H/M		Lean, root and butt rot, dead branches
15	10	10' N. of cabin	PP	11	X			H/H	X	Weak crotch

Tree No.	Lot No.	Location	Species	DBH	Potential Target			Rating	Dead	Comments
					Structure	Vehicle	People			
16	11	50' NW of cabin	PP	13	X			M/M	X	Recent dead
17	13	45' W. of outhouse	PP	11	X			M/M	X	Cluster of 3 recent dead
18	13	45' W. of outhouse	PP	7	X			M/M	X	
19	13	45' W. of outhouse	PP	11	X			M/M	X	
20	13		PP	9	X	X	X	M/H	X	
21	13	W. of house; near driveway	PP		X	X	X	M/H	X	7 trees average d.b.h. 8 inches
22	16	5' W. house	PP	15	X	X		M/H	X	
23	16		PP	21	X			M/M	X	
24	16		PP	27			X	M/L	X	
25	16	20' S. house	PP	10	X	X		M/H	X	
26	16		PP	16	X			H/H	X	
27	16	E. of house 60'	PP	12	X	X		M/M	X	
28	16		PP	12		X		M/M	X	
29	17	100' S. of house	PP	11	X			H/H	X	Powerline
30	17	30' SW of cabin	PP	12	X			M/H	X	
31	17	E. of cabin	PP	5		X		M/M	X

Tree No.	Lot No.	Location	Species	DBH	Potential Target		Rating	Dead	Comments
					Structure	Vehicle People			
32	17	NE of cabin	PP	12		X	M/L	X	
33	18		PP	8		X	M/L	X	
34	19		PP	10		X	M/L	X	
35	19		PP	8		X	M/L	X	
36	19		PP	7		X	M/L	X	
37	19		PP	7		X	M/L	X	
38	19		PP	6		X	M/L		
39	20	NW of cabin, 50-60'	PP	16	X	X	M/M	X	
40	20	NW of cabin, 50-60'	PP	12	X	X	M/M	X	
41	20	NW of cabin, 50-60'	PP	22	X	X	M/M	X	
42	20	NW of cabin, 50-60'	PP	16	X	X	M/M	X	
43	20	10' W. side house	PP	9	X		H/H	X	
43	20		PP	6	X		M/H	X	
43	20	6' E. cabin	PP	4	X	X	M/M	X	
44	20 & 21	along road	PP	10	X		M/H	X	Powerline
44	20 & 21		PP	14	X		M/H	X	Powerline
44	20 & 21		PP	9	X		M/H	X	Powerline

Tree No.	Lot No.	Location	Species	DBH	Potential Target			Rating	Dead	Comments
					Structure	Vehicle	People			
45		NW of tanks	PP	17	X			M/H	X	Near water tanks
46	29		PP	14	X			L/M	X	Powerline
47	26	80' SW from cabin	PP	28	X			M/L	X	Lean 5°
48	25	W. of cabin	PP	22		X		M/L	X	Lean 5°
49	25	NW of cabin	PP	24		X		M/M	X	
50	30	20' SW house	PP	20	X			M/H	X	
51	30	east of driveway	PP	25		X		L/M		Broomed, lightning struck
52	23	100' NW cabin	PP	17		X	X	M/L	X	
53	22	W. from #22; 45' from driveway	PP	11	X			M/M	X	Powerline
54	31	50' E. cabin	PP	16	X			M/M	X	Powerline
55	33	NE of cabin	PP	16	X			L/L	X	Brooms
56	33	SW of cabin	PP	11	X			M/M	X	Powerline
57a	33	SW of cabin	PP	7	X			M/H	X	Powerline
57b	33	SW of cabin	PP	9	X			M/H	X	Powerline
57c	33	SW of cabin	PP	6	X			M/H	X	Powerline
57d	33	SW of cabin	PP	4	X			M/H	X	Powerline

Tree No.	Lot No.	Location	Species	DBH	Potential Target			Rating	Dead	Comments
					Structure	Vehicle	People			
58a	35		PP	7	X			M/H	X	Powerline
58b	35		PP	5	X			M/L	X	Powerline
59	37	20' SW of cabin	PP	21	X	X		H/H	X	
60	38	90' N. of cabin	PP	24	X	X		M/M	X	
61	39	SE cabin, 50' from road	PP	29		X		H/L	X	
62	39	W. of cabin, 60'	PP	16	X			M/M	X	
63	42	SW cabin, 20'	PP	21	X			H/H	X	
64	41	15' E. of outhouse	PP	24	X			M/L	X	
65	53		PP	6			X	M/L	X	
66	48	40' E. of RD, 90' S. of cabin	PP	23	X			H/L	X	Near main road
67	48	10' SW	PP	19	X			H/H	X	Old dead
68	47	40' S.	PP	21		X	X	H/L	X	
69		N. of 44, 200'	PP	8	X			H/L	X	Near road
70		W. of road, between 47 & 45	PP	10	X			M/L	X	Near road

<u>Lot</u>	<u>d.b.h.</u>	<u>DM Rating</u>	<u>Prunable brooms</u>
8	25	2	1
9-10	27	4	6
11	25	1	1
10	16	2	1
10	16	2	1
9-10	17	2	1
9-10	16	2	1
9-10	15	4	5
10	18	2	3
10	12	4	4
10	13	3	1
10	19	4	4
11	13	4	11
11	17	2	4
11	12	2	1
11-12	29	4	5
11-12	26	5	4
11-12	20 (double tree)	4	6
11-12	18	4	6
12	20	4	5
12	17	4	4
12	18	3	5
12	11	3	4
12	18	3	5
12	11	3	4
12	15	3	3
12	16	2	3
12	19	3	2
12	15	4	6
12	15	4	4
13	26	4	5
14	24	4	5
14	29	2	5
14	19	3	4
14	14	5	4
14	19	4	6
22	24	3	3
22	20	2	3
25-26	23	4	12
51	30	3	3
51	22	4	6
51	29	4	9
51	26	4	6
51	17	5	4
51	18	2	3

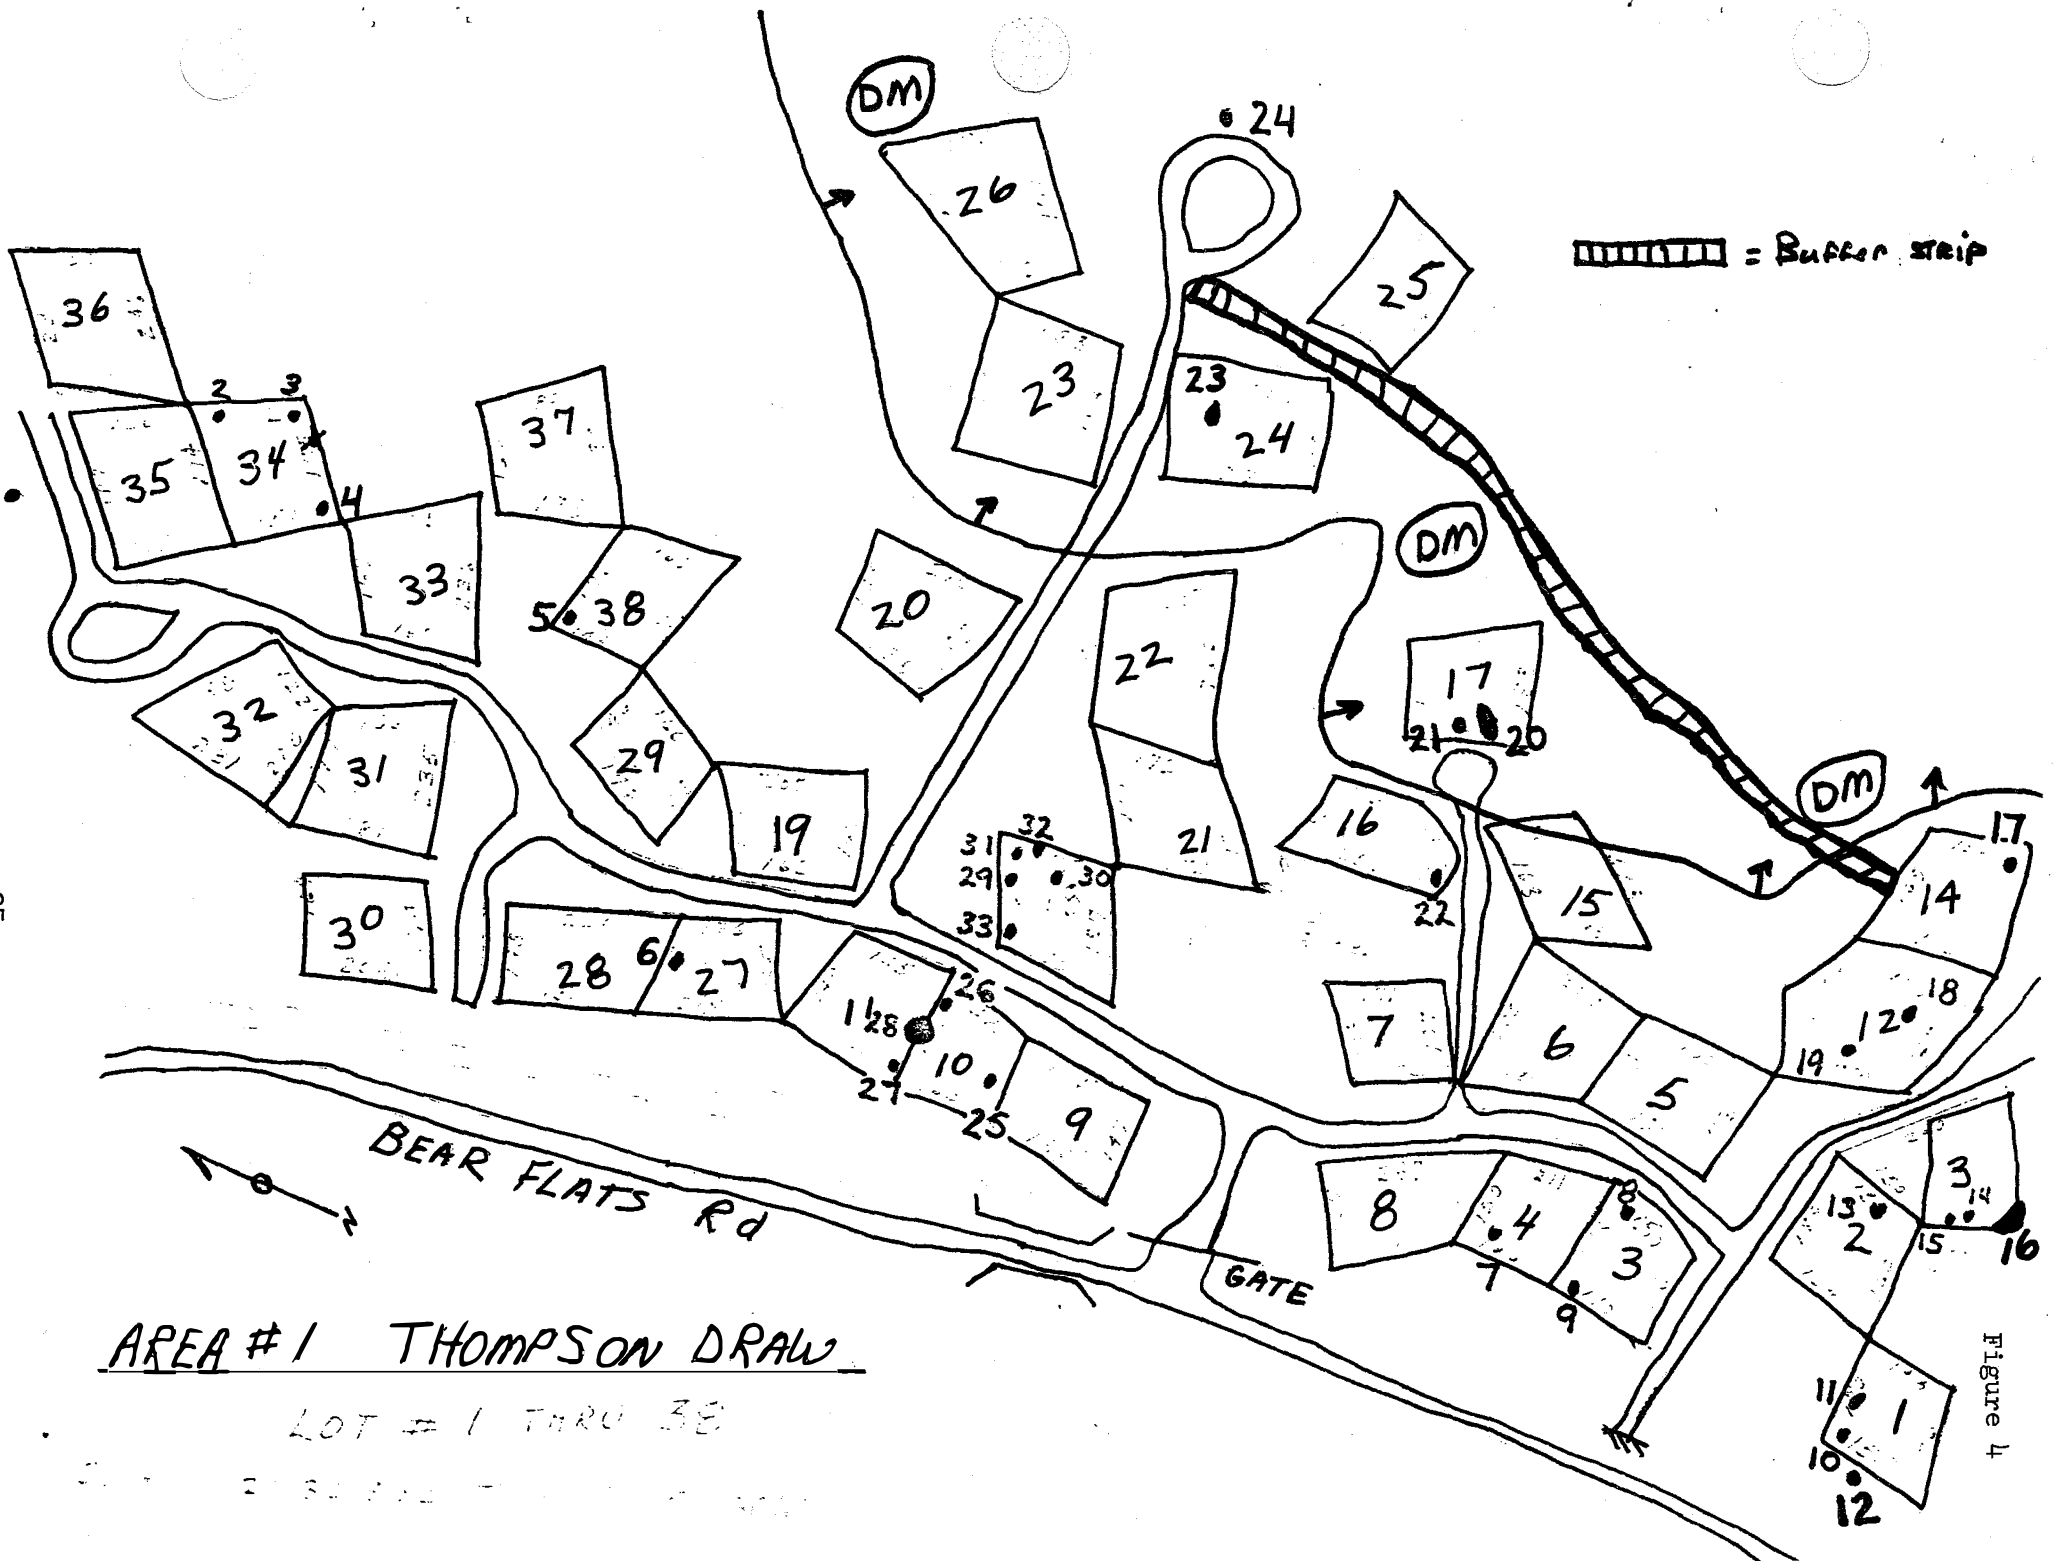
Figure 4

Thompson Draw, Block 1--Mistletoe is located west of a line from lot 14 through lots 15, 16, 17, 22, 24, 23, 20, to 26. The prescription for Thompson Draw, block 1, includes sanitizing lots 16 and 17, broom pruning large, valuable trees on lot 25, and cutting a buffer strip, already flagged, from lot 14 north to lot 24 (figure 4, appendix 4).

Tree No.	Lot No.	Location	Species	DBH	Potential Target			Rating	Dead	Comments
					Structure	Vehicle	People			
1	35	W. of #35	PP	25		X		L/L		20° lean across road; undercut by stream; dead roots on stream side.
2	34	N. 70' from house	PP	5		X		M/L	X	
3	34	30' NE of house	PP	24	X	X		M/H		5° lean; fire scar; butt rot
4	34	SE of Lot 34	PP	17	X			H/L	X	snag
5	38	50' NE of house	PP	25	X	X		M/H	X	snag; 5° lean; telephone line attached
6	27	E. 10' of house	PP	5	X			H/H	X	5° lean over house
7	4	S. 30'	PP	7	X			H/M	X	10° lean
8	3	N. of house	Oak	12		X		M/L		butt rot; limb defect; dead top
9	3	150' west of house	PP	32	X	X		H/H	X	snag; 5° lean
10	1	S. 50'	PP	6			X	H/M	X	leaning
11	1	S. 50'	PP	6	X			H/L	X	leaning
12	1	75' SW of house	PP	8			X	H/L		leaning; root rot; butt rot
13	2	N. 50'	PP	5		X		H/M	X	leaning

Tree No.	Lot No.	Location	Species	DBH	Potential Target			Rating	Dead	Comments
					Structure	Vehicle	People			
14	13	75' SE of house	Oak	12	X		X	M/M	X	leaning; swing attached to tree
15	13	75' SE of house	Oak	19	X			M/H	X	leaning
16a	13	SE house; 5 tree group	PP	18	X			M/M	X	
16b	13	" "	PP	11	X			M/M	X	
16c	13	" "	PP	11	X			M/M	X	
16d	13	" "	PP	14	X			M/M	X	
16e	13	" "	PP	14	X			M/M	X	
17	14	30' NE cabin	PP	7	X			H/L	X	
18	14	W. of house over driveway	Oak	7		X		L/L	X	
19	12	40' E. of house	PP	7		X		H/M	X	
20a	17		PP	6			X	H/M	X	
20b	17		PP	7			X	H/M	X	
21	17	40' SE of house	PP	17	X	X		M/M	X	5° lean
22	16	S. of 16	PP	30	X			L/M		powerline; dead top
23	24	40' N of house	PP	18	X		X	L/M	X	outhouse

Tree No.	Lot No.	Location	Species	DBH	Potential Target			Rating	Dead	Comments
					Structure	Vehicle	People			
24	25	entrance to 25	PP	14		X		L/L	X	
25	9	between 9 & 10	PP	5	X			H/H	X	35° lean; tele- phone line
26	10	30' from outhouse N. of house	PP	7	X			H/M	X	outhouse
27	11	15' S. of house	PP	29	X	X		M/H		butt rot; basal cavity
28	10	DBH's 4 trees	PP	6, 7, 7, 12	X			M/M	X	butt rot; basal cavity
29	18	W. 30' from cabin	PP	6	X	X		M/M	X	
30	18	60' N. of cabin #29	PP	15	X			M/M		butt rot
31	18	Cluster of 3--5", 6", 8"--60' NW of house	PP	5, 6, 8	X			H/M	X	
32	18	40' NW of cabin	PP	5	X			H/M	X	powerline
33	18	70' SW cabin	PP	10	X			M/L	X	powerline

Lot 16. Cut 5, prune 17; west of lot 16, broom prune 23 d.b.h., 5 brooms.

Lot 17. North of house cut 5; south prune 6, cut 8; west prune 4, cut 6, 21 d.b.h., 10 brooms.

Between lots 15 and 17. Prune 8, cut 10.

Between lots 16 and 17. Prune 5, cut 18.

Lot 25. South of house, broom prune; 4 pines.

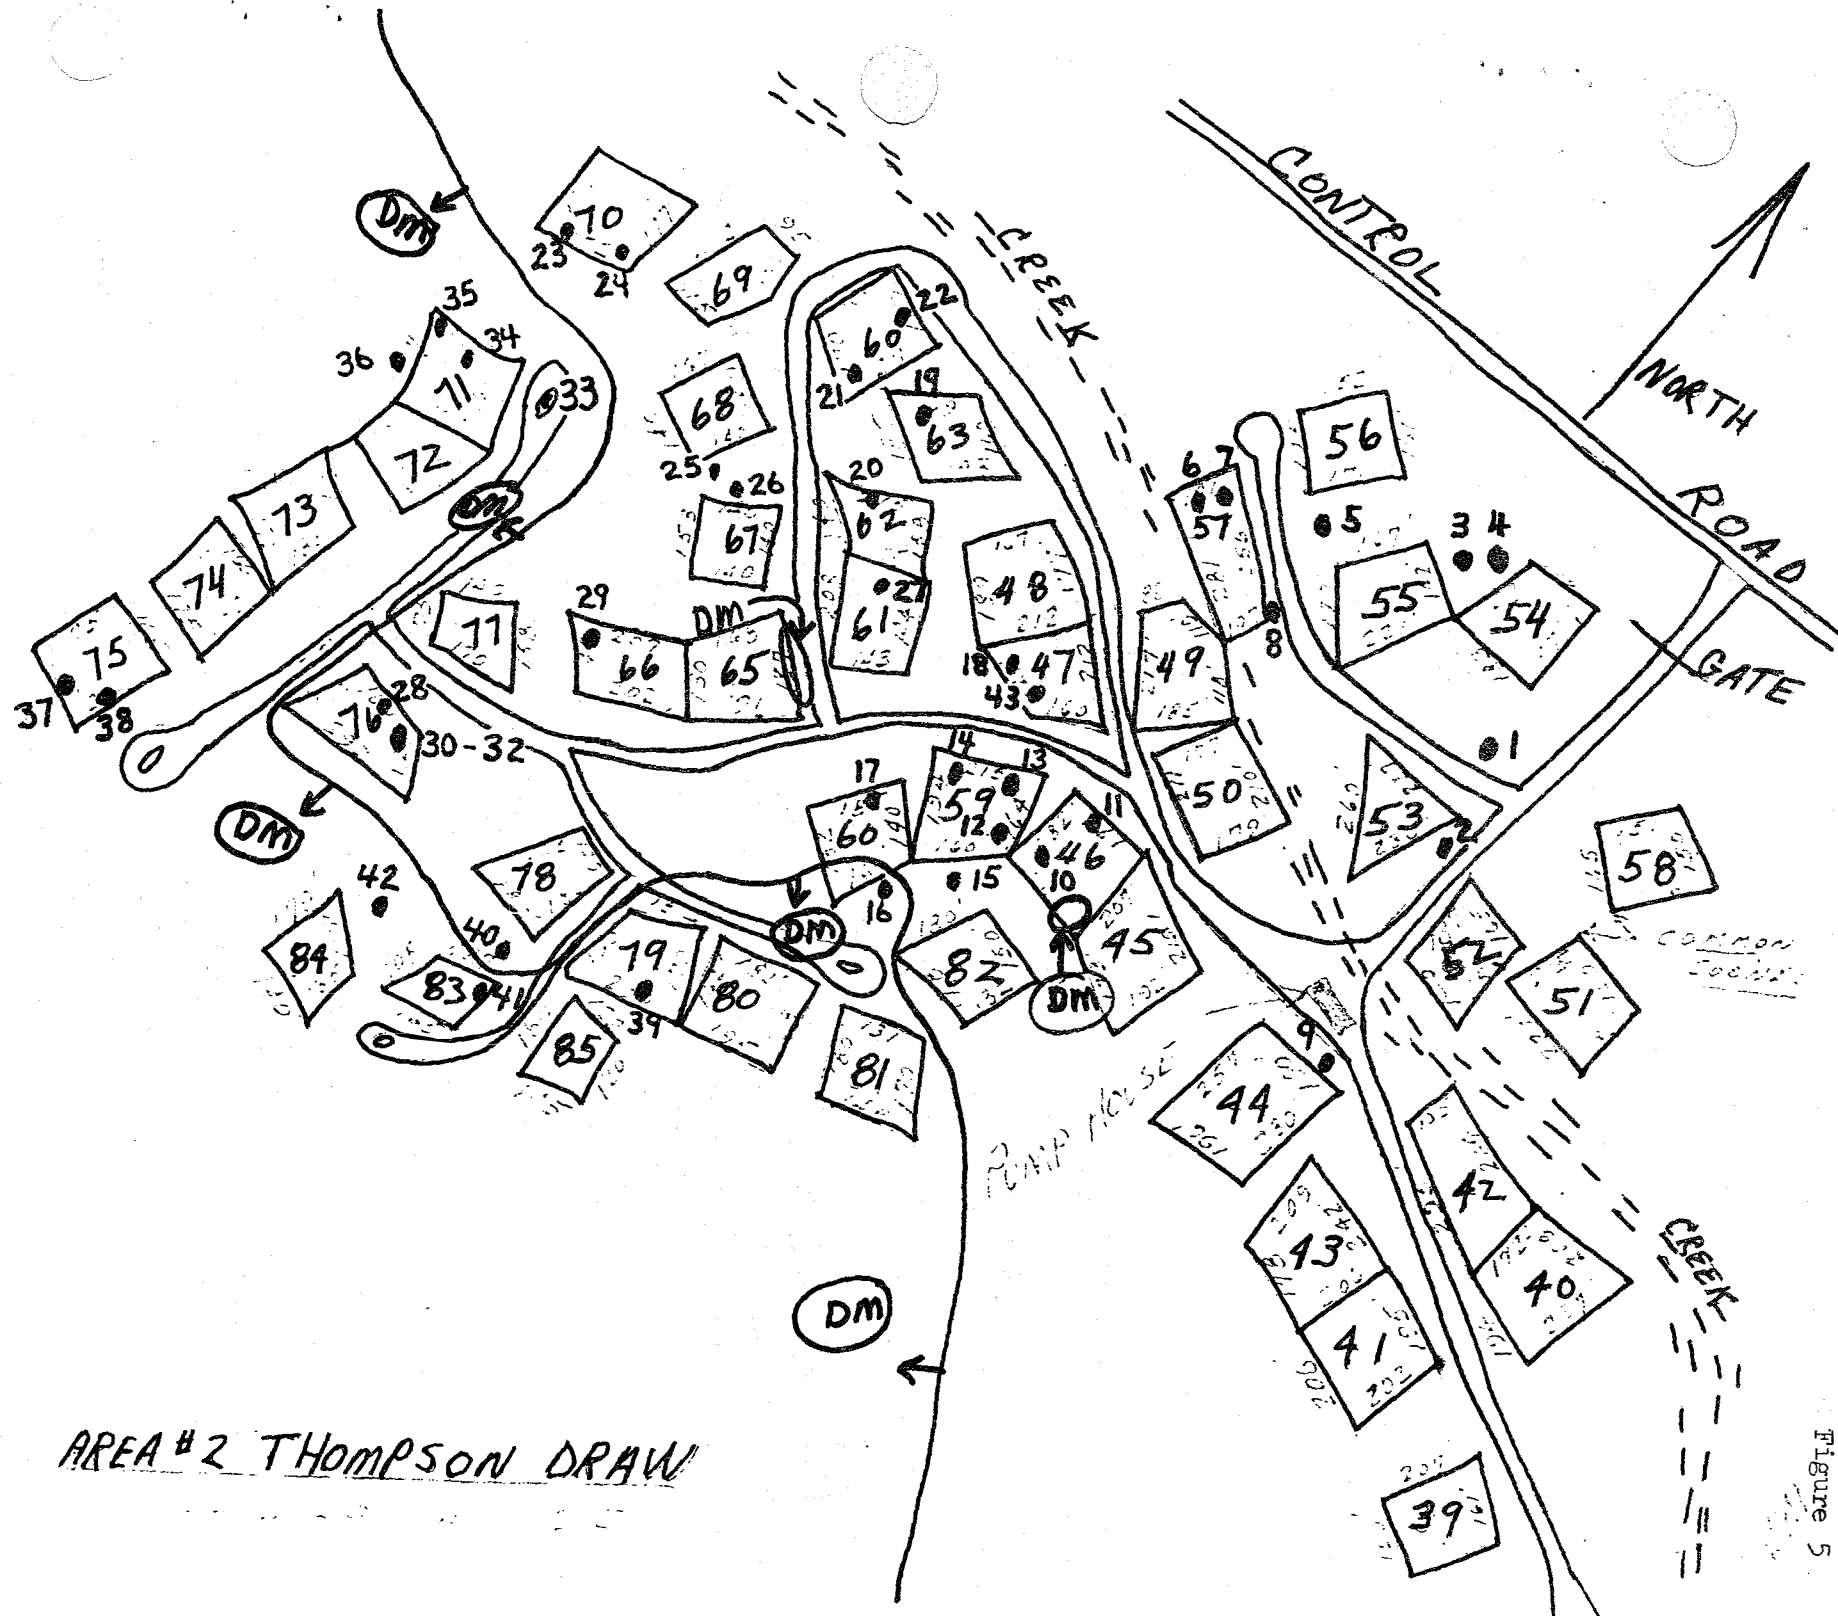
Figure 5

Thompson Draw, Block 2--Mistletoe is confined to southwest side of summer home area, figure 5. Buffer zone marked starting between lots 70 to 71, south along road to lot 77, west of 76, east to between 78 and 83. Sanitize 60, buffer zone then runs southeast between 81 and 82 out to thinning area. Sanitize 46 and 65, appendix 5.

Tree No.	Lot No.	Location	Species	DBH	Potential Target			Rating	Dead	Comments
					Structure	Vehicle	People			
1	53	100' N. cabin	PP	26				L/M	X	near road
2	53	110' NE cabin	PP	20				H/M	X	leaning 10°; butt rot; near road
3	54	120' W. cabin	PP	5			X	M/M	X	near volleyball court
4	54	120' W. cabin	PP	6			X	M/M	X	near volleyball court
5	55	60' SW cabin	PP	9				M/H	X	powerline
6	57	60' S. cabin	PP	7	X		X	M/M	X	
7	57	10' W. driveway	PP	5		X		M/M	X	
8		E. 100 yds.; lot 57, 20' S. of road	PP	17				M/M	X	powerline
9	44	20' E. driveway	PP	11				L/M		powerline; butt rot; heart rot
10	46	100' S. cabin	PP	14	X			M/L	X	outhouse
11	46	40' NW cabin	PP	7	X			M/M	X	powerline
12	59	45' NE cabin	PP	17	X			H/H	X	5° lean
13	59	25' NE cabin	PP	8	X			M/H	X	
14	59	W. cabin near road	PP	22	X			M/H	X	powerline
15	59	60' E. outhouse	PP	13	X			L/L	X	outhouse

Tree No.	Lot No.	Location	Species	DBH	Potential Target			Rating	Dead	Comments
					Structure	Vehicle	People			
16	60	100' E. cabin	PP	6		X		L/L	X	
17	60	50' NW cabin	PP	9	X			M/H	X	powerline
18	47	100' SW cabin	PP	8			X	H/L	X	
19	63	70' S. cabin	PP	12	X		X	L/M	X	
20	62	20' N. cabin	PP	7	X			M/H	X	5° lean
21	64	50' S. cabin	PP	5	X			M/H	X	
22	64	70' N. cabin	PP	32	X			L/M		
23	70	40' W. cabin	PP	9	X			M/L	X	
24	70	50' E. cabin	PP	5	X			M/M	X	
25	68	50' E. cabin	PP	17	X			M/H	X	
26	67	70' W. cabin	PP	15	X			M/M	X	
27	61	65' NW cabin	PP	5	X			M/M	X	
28	76	70' NW cabin	PP	3	X			M/M	X	powerline
29	66	40' W. of garage	PP	5	X			M/L	X	
30	76	100' W. cabin	PP	6	X			M/M	X	powerline
31	76	100' W. cabin	PP	5	X			M/M	X	powerline

Tree No.	Lot No.	Location	Species	DBH	Potential Target			Rating	Dead	Comments
					Structure	Vehicle	People			
32	76	100' W. cabin	PP	5	X			M/M	X	powerline
33	71	200' N. cabin	PP	11	X			M/H	X	powerline
34	71	30' N. cabin	PP	5		X	X	M/M	X	
35	71	10' S. cabin	PP	10	X			M/M	X	
36	71	30' S. cabin	PP	7			X	M/L	X	
37	75	20' W. from road	PP	14	X			M/H	X	powerline
38	75	25' W. from road	PP	9			X	M/L		5° lean
39	79	15' SE from cabin	PP	4	X		X	M/M	X	
40	83	100' S. from cabin	PP	5	X			M/H	X	powerline
41	83	80' S. from cabin	PP	4		X		M/L	X	
42	84	35' NE from cabin	PP	8		X	X	H/M	X	
43	47	20' SW cabin	Oak	19	X	X		M/M		butt rot; limb defect; dead top

Between lots 70 and 71. Prune 59, cut 166.

Lot 65. Cut 5.

Lot 46. Prune 1.

From road by lot 76 to east of lot 83. Prune 8, cut 30.

Lot 78. Prune 1, cut 3.

Lot 60. Prune 4, cut 5.

Lot 80. Prune 10, cut 6.

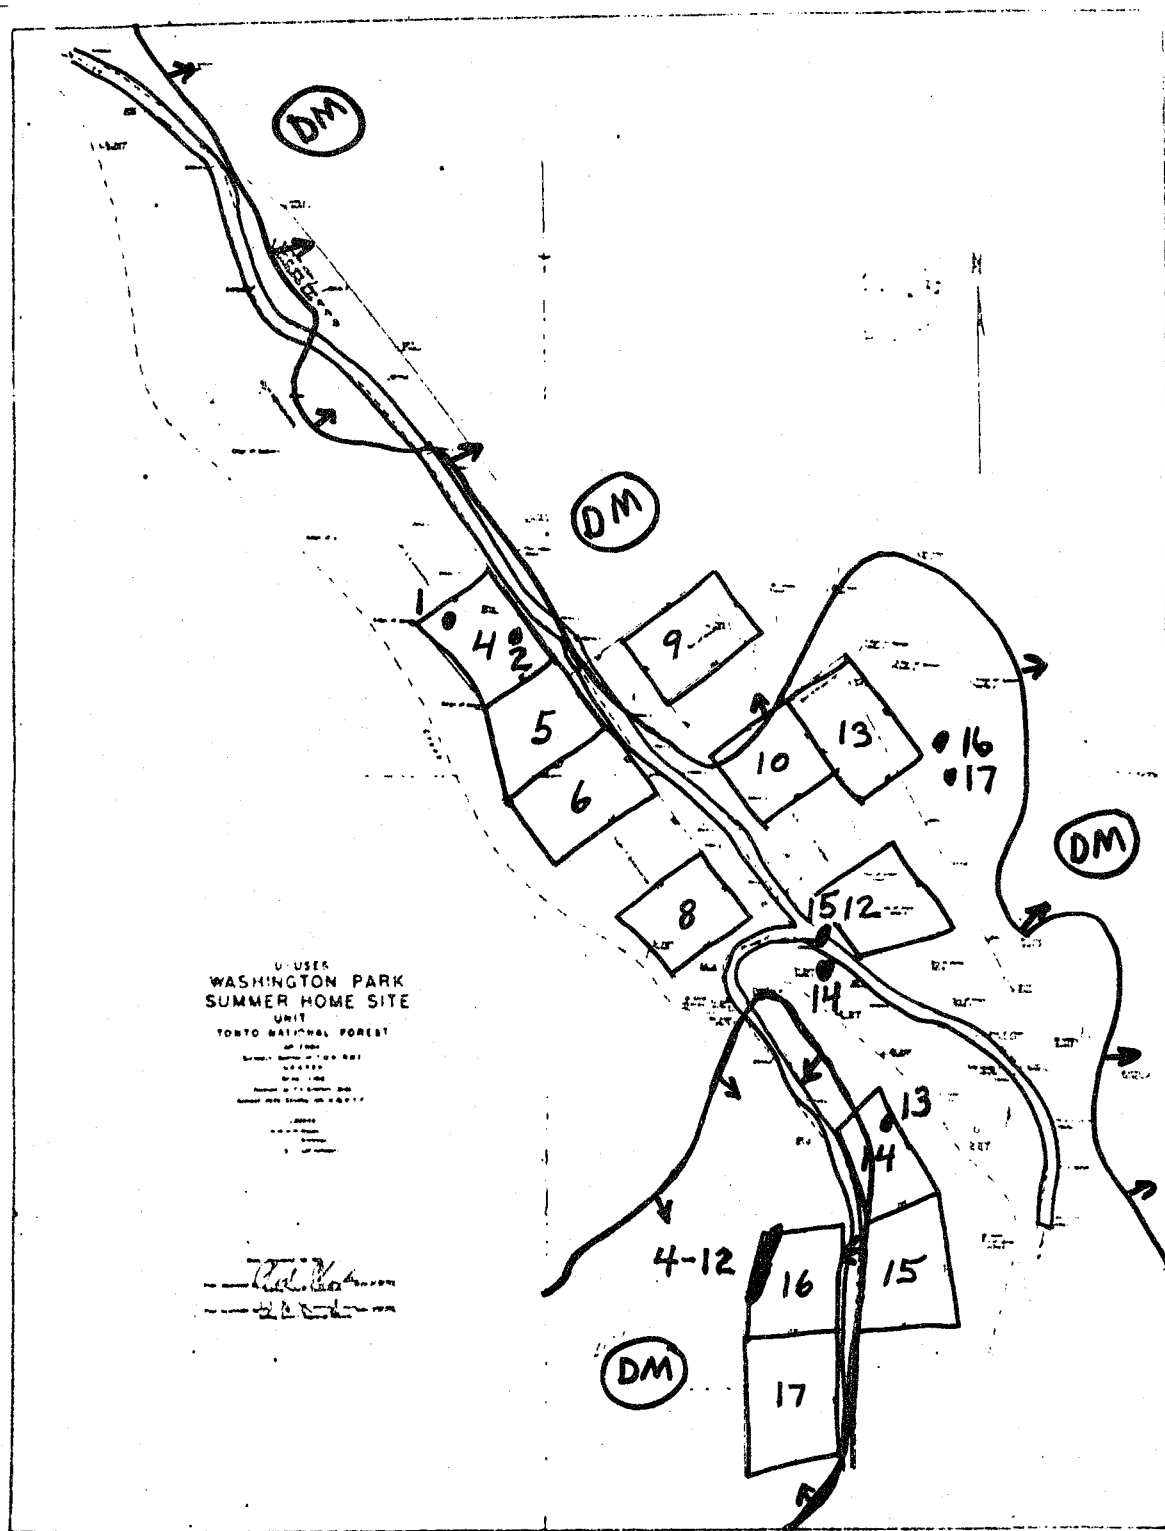
Figure 6

Washington Park--Dwarf mistletoe west of lots 16 and 17 up to road; east of road by lots 9 to 10, figure 6. The uninfected lots in Washington Park are separated from the infected trees by natural buffer zones; a road on the north and east and a concentration of resistant tree species along the stream drainage. No control is proposed other than to plant and favor resistant species on infested lots.

Tree No.	Lot No.	Location	Species	DBH	Potential Target			Rating	Dead	Comments
					Structure	Vehicle	People			
1	4	15' NW cabin	PP	34	X			L/H		5° lean; weak branch. crotch; limb defect; mechanical injury
2	4	15' E. cabin	PP	25			X	H/M	X	
3	16	50' NNW cabin	PP	13	X			H/H	X	
4	16	50' NNW cabin	PP	9			X	H/M	X	
5	16	50' NNW cabin	PP	8			X	H/M	X	
6	16	50' NNW cabin	PP	5			X	H/M	X	
7	16	50' NNW cabin	PP	14	X			M/H	X	
8	16	50' NNW cabin	PP	12	X			M/H	X	
9	16	50' NNW cabin	PP	6			X	H/M	X	
10	16	W. of cabin	PP	8			X	M/M	X	
11	16	W. of cabin	PP	9			X	M/M	X	
12	16	W. of cabin	PP	11			X	M/M	X	
13	14	20' N. cabin	Oak	23			X	M/L		heart rot; broken top
14	12	50' W. across road from cabin	Oak	21	X	X		H/M		leaning; root rot; heart rot; dead top

Tree No.	Lot No.	Location	Species	DBH	Potential Target			Rating	Dead	Comments
					Structure	Vehicle	People			
15	12	90' SE cabin	PP	27	X	X	X	M/M		butt rot; basal cavity; mechanical injury; lightning injury; heart rot
16	13	55' S. cabin	PP	22			X	M/L	X	
17	13	75' S. cabin	PP	34	X			M/L		overmature-thin crown; fire wound
